Tower Access - Guidance Notes.

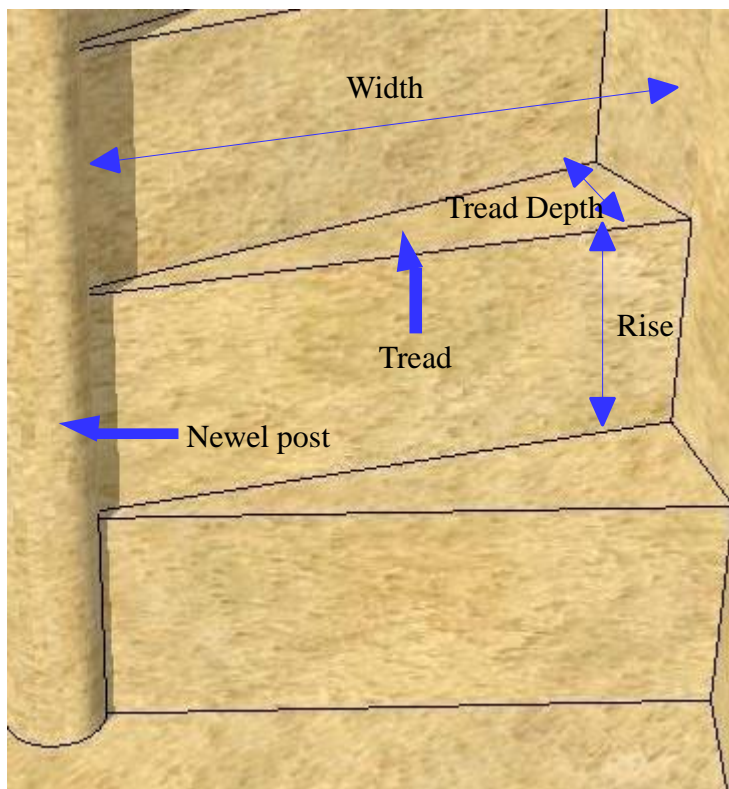
Figure 1.

The terminology used is all covered by the diagram below. Definitions are given alongside.

Newel / Newel Post; The central column of a spiral stairway.

Rise; The height of a stair from the tread below.

Tread; the horizontal surface of a stair upon which users step.

Tread Depth; The horizontal distance from the front edge of a tread to the back edge. For spiral stairs an indicative value is measured 300mm (12") from the outer wall of the stairway.

Width; Distance between the outside of the newel post and the outer wall of the stairway.

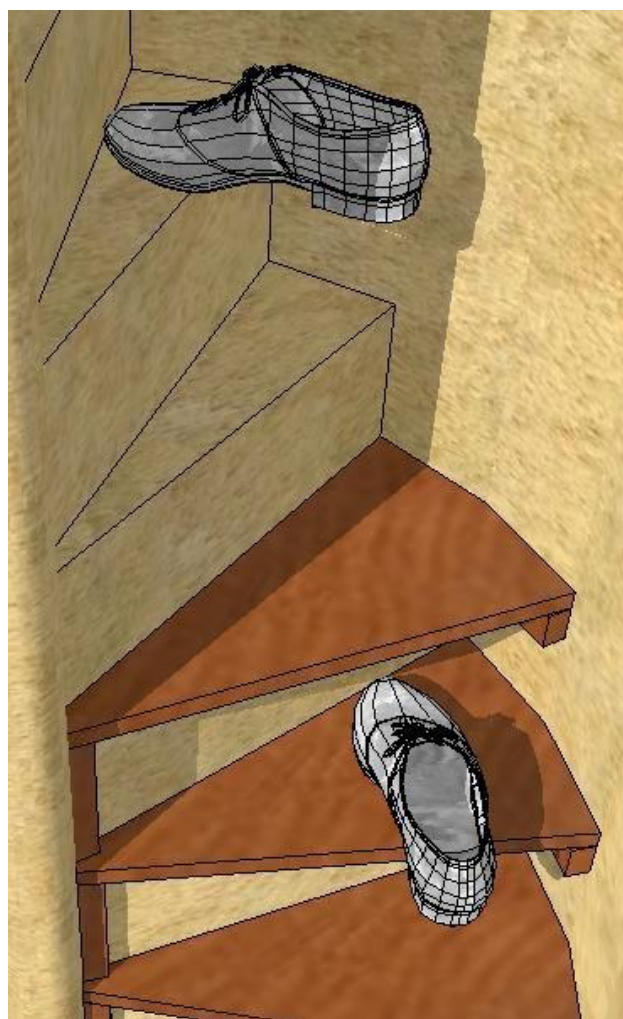
Figure 2.

When a spiral stairway is excessively steep the depth of the treads can be so small that the user is climbing with only their toes on the tread and descending on their heels. In such a situation it is possible to have wooden treads fitted which extend forward from the stone ones. These allow the user to put more of their foot upon each tread while the tread above overhangs.

(See figure 2)

Such extended treads **MUST** be supported at the front edge by suitable brackets or blocks fixed to the outer wall and newel post.

Stairs modified in this way should be descended backwards or the advantage is negated.

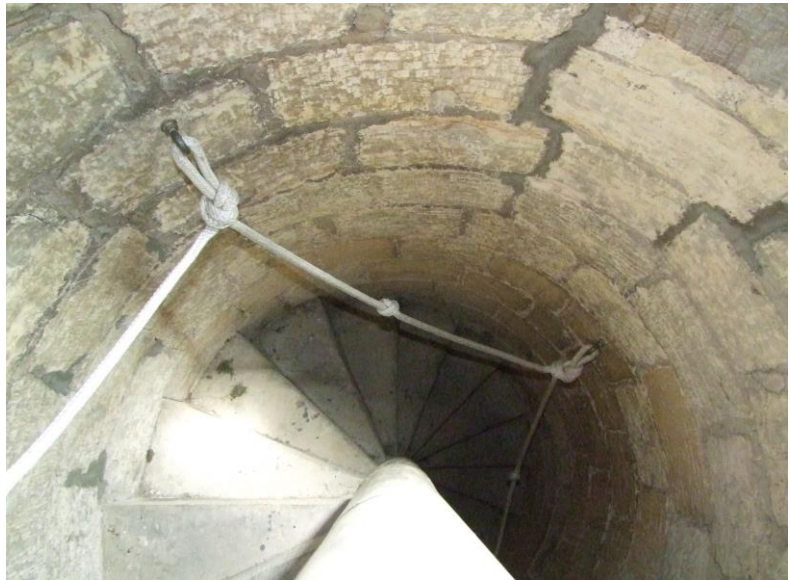
Figure 4

A hand-rope suffers from an even worse form of the same problem. If the rope is fixed even as often as six times per turn of the stairway it will reduce the usable width by more than 15% due to the rope "cutting the corner" off the stairway. An extreme example may be seen in figure 4.

As a result external hand ropes should not be installed unless fixed very frequently and in a wide staircase.

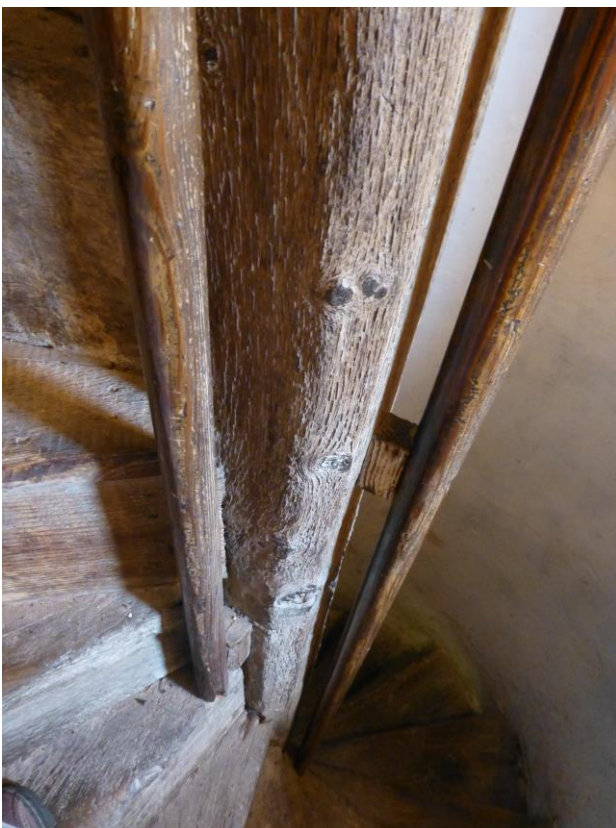
Figure 5 shows a series of vertical handrails on a stair-way which has much to recommend it. It is suitable for users of any height, it is sturdy and takes up minimal space. It is also very easy to install.

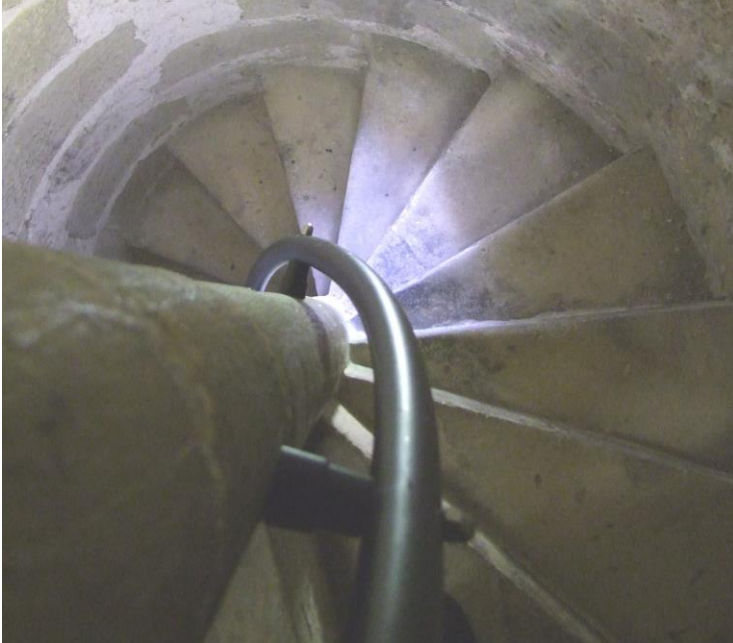
Figure 6

Tough plastic water pipe is often used as a cheap handrail that can be easily fitted. The supporting brackets must of course be close enough together to provide adequate support and stiffness to the handrail (see figure 6). MDPE water pipe may be purchased in coils of 25 or 50 meters length and in various diameters. For handrails 25 or preferably 32 mm diameter should be used.
