Lighting in and around church towers – a guide for bell-ringers

Central Council of Church Bell Ringers

Towers and Belfries Committee

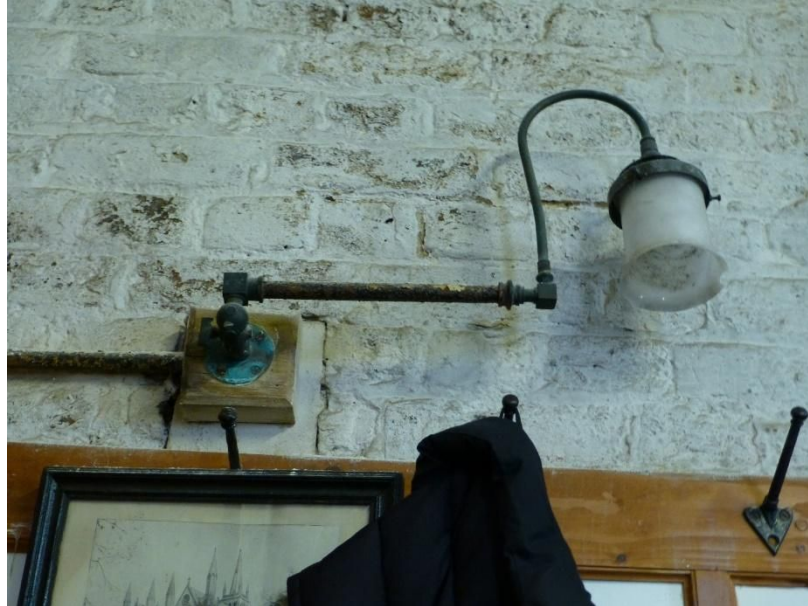
Is this the state of the art in your tower? Gas lighting is not state of the art!

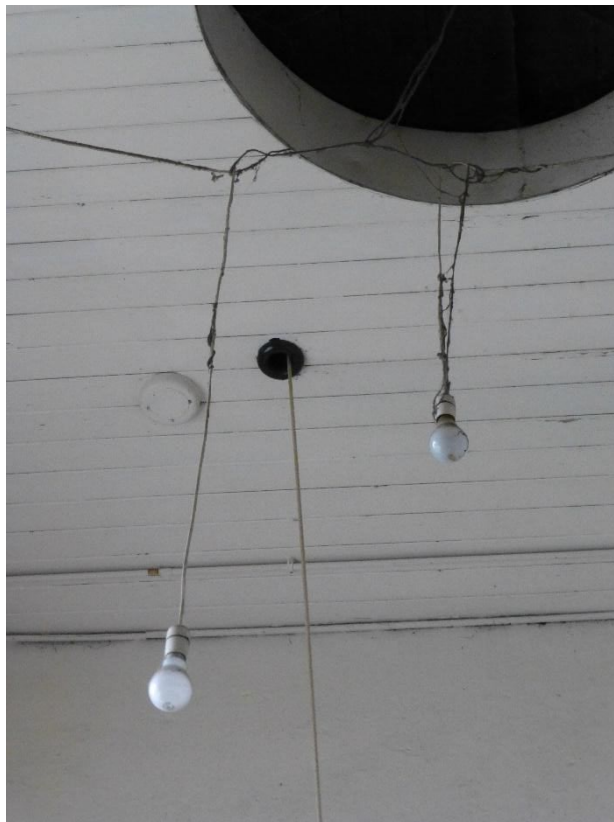
Not an acceptable arrangement!

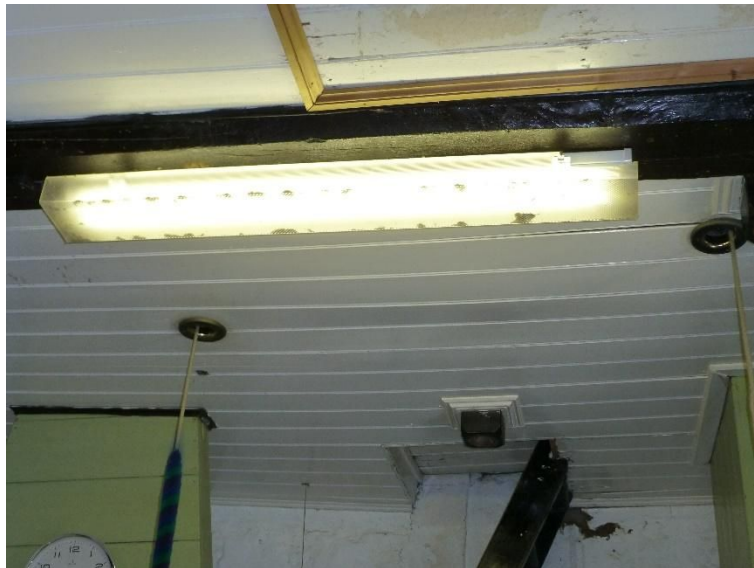
The picture above shows a typical strip light with diffuser, now with some debris building up.

Shading – The light must be diffuse; depending on the source, diffusers may be required. Many modern sources are much more intense and directional than traditional bulbs so care is required when installing new fittings at the same location as a previous lamp. The style of shade also requires careful selection. If dust, insects, spiders or other debris can easily collect in a shade or diffuser, this will soon reduce the light efficiency and potentially become a fire hazard. Ringers should not be expected to clean out lamp shades, at frequent intervals.

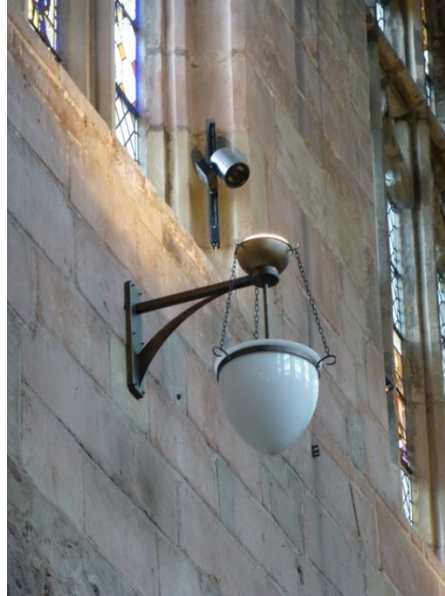
This picture shows a recent installation in the body of a church - a dual fitting with uplighter and down-lighter and, adjacent to this, a spot light. This arrangement enables different lighting effects for different functions in the church. However, this would not be suitable in a ringing room. The challenge here is that scaffolding is required for every bulb change, and debris is already building up in some of the globes. No doubt, dust will also be settling on the uplighters and hence reducing efficiency.

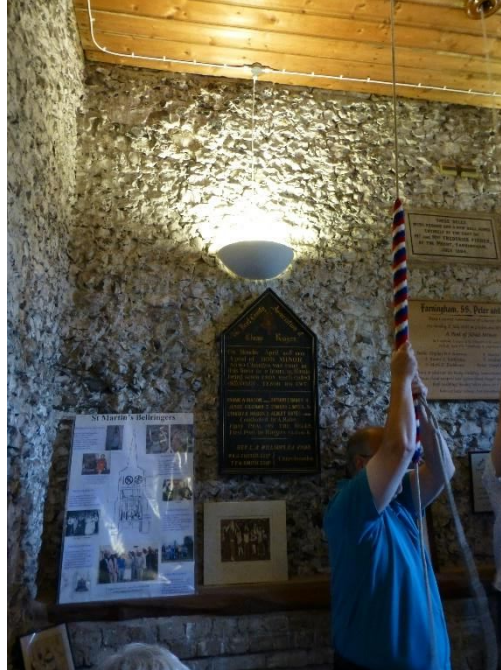
In the picture above, the uplighter is giving a good light out of the way of ropes and ringers. Inevitable, it may still collect debris.

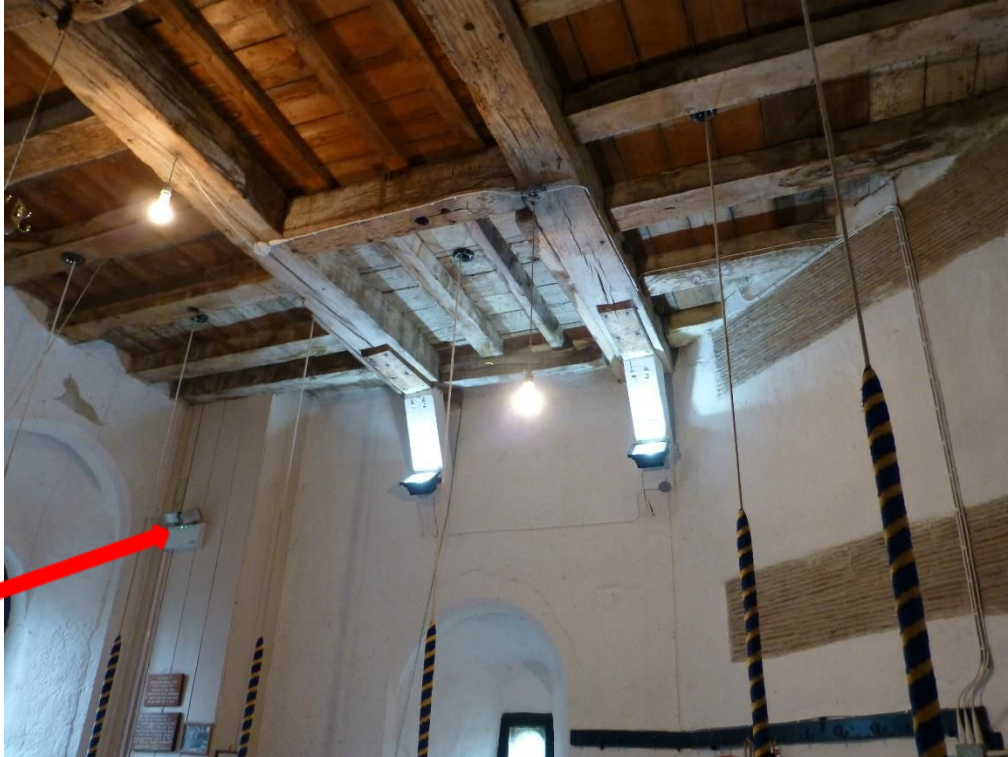
In this tower (above), there are bulbs and uplighters, with emergency lighting (arrowed).

Emergency systems – This should be integrated with the church system in case of power cuts. Ideally, the lighting is integrated with the emergency exit signage. The light source is usually a low power consumption lamp run from rechargeable batteries. Integrated emergency lighting is normally installed with fire / heat proof cable. If not integrated with the church system, then a separate system may be purchased and installed relatively economically and safely. While most people using the church may expect to leave in the event of an extended power failure, ringers may (if safe otherwise to do so) wish to continue ringing for up to 45 minutes or even the greater part of 3 hours! Whatever approach is adopted, the system should be tested periodically.
