Lighting in and around church towers – a guide for bell-ringers

Central Council of Church Bell Ringers

Towers and Belfries Committee

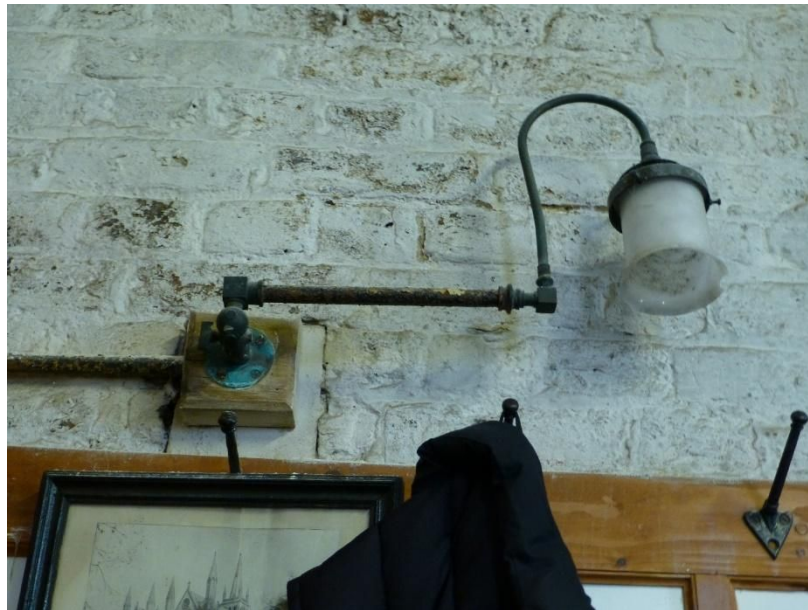
Is this the state of the art in your tower? Gas lighting is not state of the art!
